RE: Stage 4 Completion Report - Yaldhurst Park, Yaldhurst , Christchurch
(Our Reference: 15518.000.000_24)

1 Introduction

ENGEO Ltd was requested by the developer, Infinity Yaldhurst Limited, to undertake construction monitoring of the subdivision development at Yaldhurst Park, Yaldhurst , Christchurch. ENGEO has been requested to produce a completion report for Stage 4 (this document).

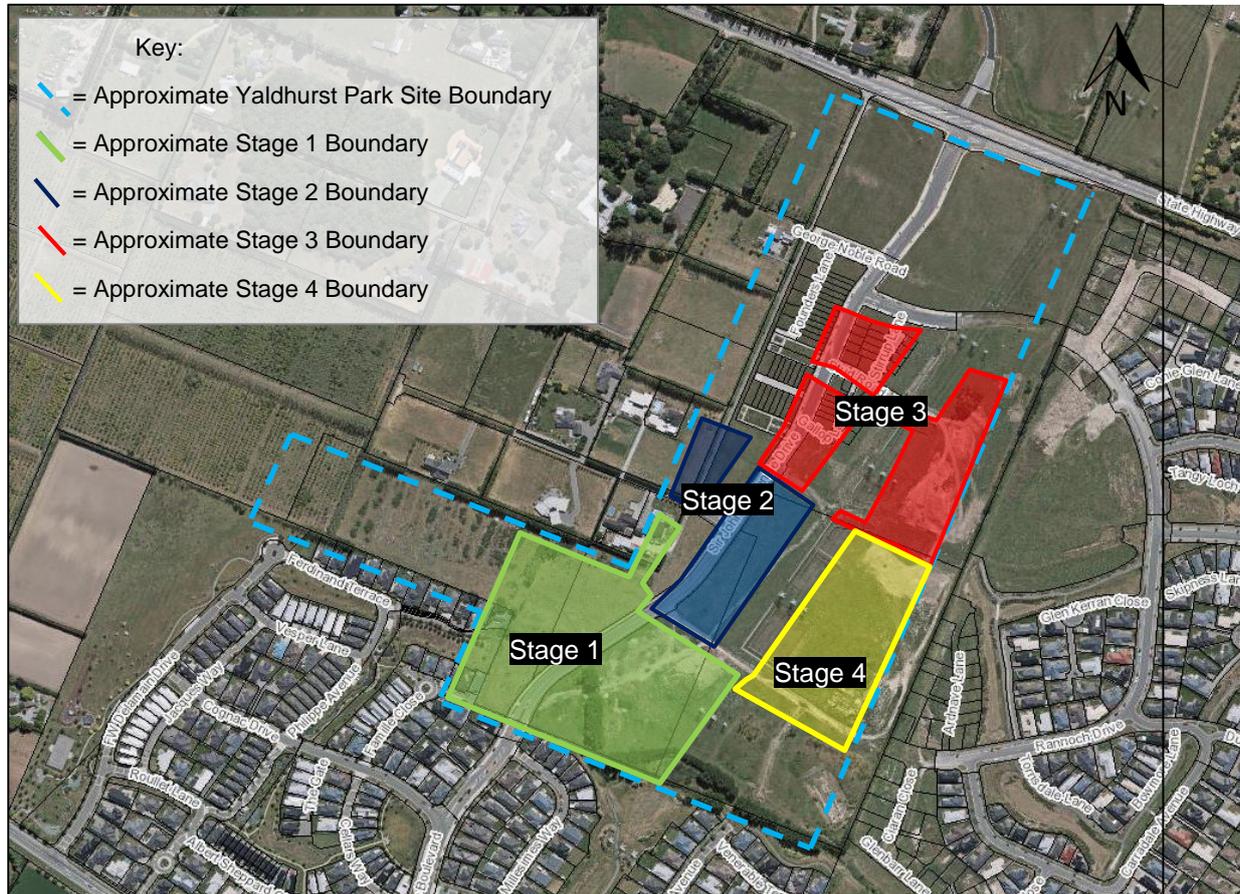
Figure 1: Subdivision Plan

The proposed Stage 4 development involves subdividing the existing land (approximately 3 ha area) into 44 residential lots in the approximate area shown in Figure 1.

Image sourced from Canterbury Maps. Not to scale.
